PHANTOM TELEGRAMS – Cause and remedy of faulty telegrams at serial output

PHANTOM TELEGRAMS

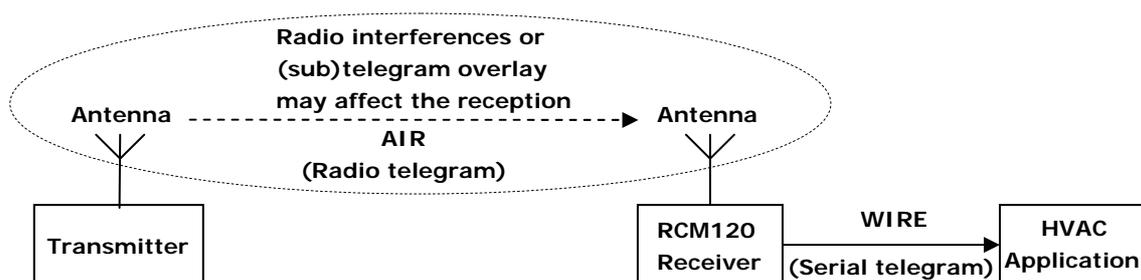
To understand the possible causes, it is important to know some details regarding the radio transmission. A typical EnOcean radio telegram consists of three identical (redundant) ASK modulated subtelegrams, transmitted within an around 60 milliseconds time slot. Within this 60 ms time received redundant sub-telegrams are combined again by the receiver logic to one serial output telegram. During the decoding of the received radio sub-telegrams (analogue data stream through air) into a digital serial (wired) telegram, a decision must be made due to the signal strength, whether the received radio signal is to be rated digitally as “1” or “0” on the serial wired output. The decoding accuracy (security in the 1/0 distinction) depends on the signal-to-noise ratio and becomes smaller with smaller signal-to-noise ratio. Background: Because of limited resources, only a simple checksum is actually implemented into the RCM receivers, not a comprehensive CRC. If more than one bit is incorrectly decoded and in dependence on the bit location of the affected bits, a (sub)telegram can be regarded as valid by the simplified internal checksum, although it is corrupted. Crucially for the appearance of such “phantom telegrams” is always the signal-to-noise ratio of the received signal.

With lower signal-to-noise ratio the probability for phantom telegrams rises. If for example the signal strength due to range limit distances (also due thick walls or screens) sinks in the background noise, more phantom telegrams are to be expected. A too small signal-to-noise ratio can be also caused naturally by higher background noise, for example by the strong irradiation of a disturber e.g. too close vicinity of the device to a strong source of interference, e.g. a switched (noisy) power supply, a wireless earphone or a mobile weather station using the same frequency, or even unfavorable antenna situations.
