PHANTOM TELEGRAMS –

Cause and remedy of faulty telegrams at serial output

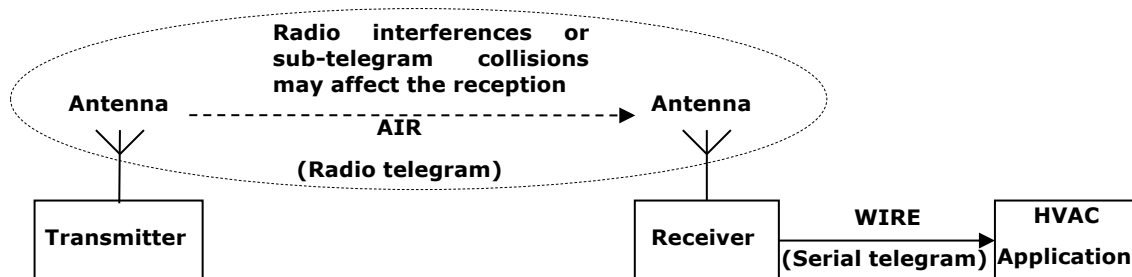
To understand the possible causes, it is important to know some details regarding the radio transmission. A typical EnOcean radio telegram consists of three identical (redundant) ASK modulated sub-telegrams, transmitted within an around 40 milliseconds time slot. Within this period, received redundant sub-telegrams are combined by the receiver logic to one serial output telegram. During the decoding of the received radio sub-telegrams (analogue data stream through air) into a digital serial (wired) telegram, a decision must be made due to the signal strength, whether the received radio signal is to be rated digitally as "1" or "0" on the serial wired output. The decoding accuracy (security in the 1/0 distinction) depends on the signal-to-noise ratio and becomes smaller with lower signal-to-noise ratio. Background: Because of limited resources, just a simple checksum is implemented in the receivers, not a comprehensive CRC. If more than one bit is incorrectly decoded, in dependence on the bit location of the affected bits, a sub-telegram can be regarded as valid by the simplified internal checksum, although it is corrupted. Crucially for the appearance of such “phantom telegrams” is always the signal-to-noise ratio of the received signal.

With lower signal-to-noise ratio the probability for phantom telegrams rises. If for example the signal strength due to range limit distances (also due thick walls or screens) sinks in the background noise, more phantom telegrams are to be expected. A too small signal-to-noise ratio can be also caused by higher background noise, for example by the strong irradiation of a disturber, too close vicinity of the device to a strong source of interference, e.g. a switched (noisy) power supply, a wireless earphone or a mobile weather station using the same frequency, long range RFID readers or unfavorable antenna situations.
